Channel Mitigation Monitoring Sheets I, II, III, AND IV

Monitoring Data Record

Project Title: R-2417BB (Site 6) COE Action ID: 200201326

City, County and other Location Information: Lee County, Sanford Bypass (Sta. 540+20 to 555+00 -L- RT.)

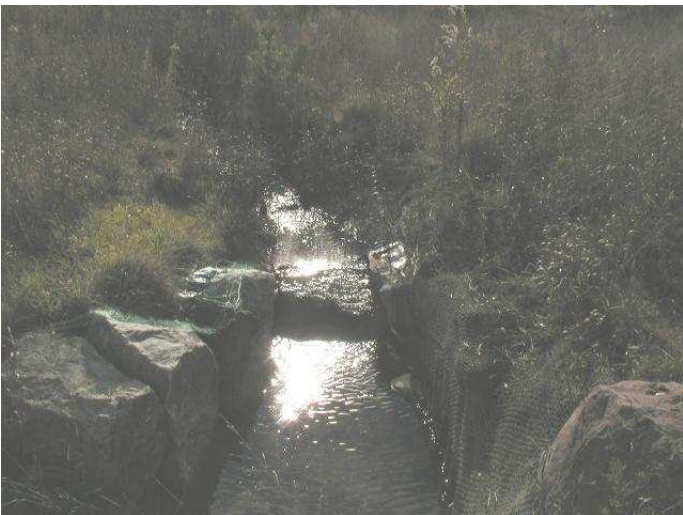
Photo Point #6 (Upstream)

This is the 7th quarterly monitoring evaluation for this stream relocation. The crossvane @ Sta. 546+75 (PP #6 Upstream) that required remedial action prior to the 4<sup>th</sup> Quarter evaluation is functioning properly at this time. The stream relocation is highly stable. NCDOT will continue to monitor this stream relocation.
